## CHAPTER III

# Achieving Seismic Safety in Buildings

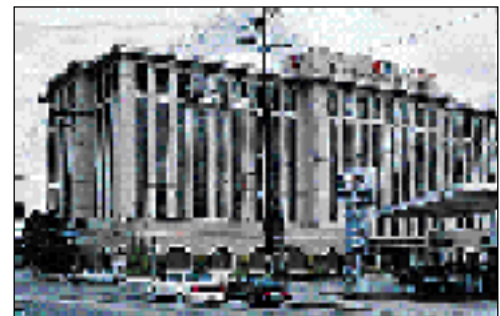
- There were many failures of welded-steel moment-frame joints in the Northridge earthquake. The building codes allowed major investments in this type of construction although, in hindsight, there has clearly been a lack of substantiating research to verify the adequacy and reliability of welded-steel moment-frame joints. The code changes in the 1960s that allowed these fully welded steel frames were based on small-scale tests of steel beams that were on the order of ten times lighter and one-fourth the depth of beams now in wide use. Minor investments in full-scale tests back in the 1960s could have saved the industry from billions of dollars in Northridge earthquake losses alone. Had there been strictly enforced testing criteria for the acceptance and verification of building code changes, the problems with steel-frame joints could have been avoided (figures 23 and 24).

**Figure 24.** Cracks in slightly damaged steel buildings were often undetected until months after the earthquake.

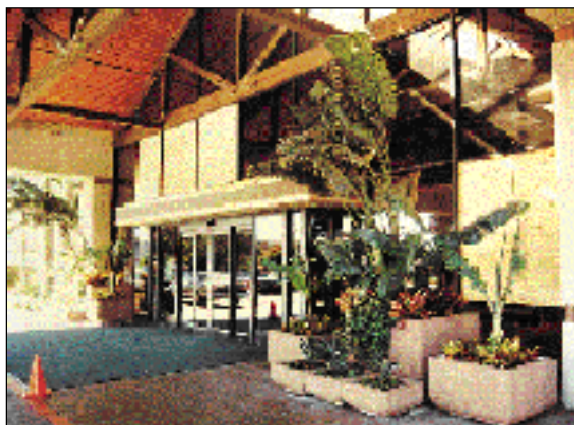
Breakage of glass often occurs at entries to buildings, a location that maximizes the potential for injuries. Aftershocks are a particular danger with this nonstructural component. The broken panes pictured in Figure 30 were misaligned and some cracked in the main shock at 4:31 a.m., but it was an aftershock that caused the panes to fall out. Figure 31 shows how such buildings are posted with placards, raising the issue of whether nonstructural post-earthquake safety criteria need more emphasis.

**Figure 30.** Large broken windows at a hotel entrance pose major falling hazards.

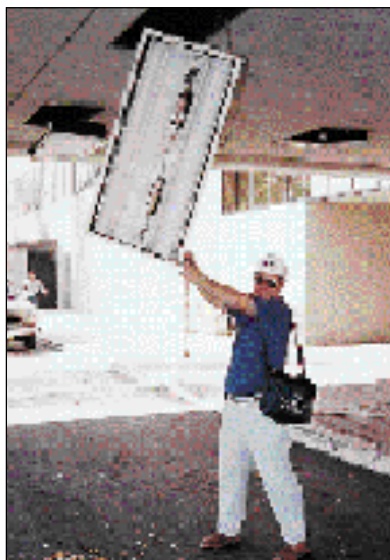
- Nonstructural components are more vulnerable to damage at low-to-moderate levels of shaking than structural elements. Even at higher levels of shaking, nonstructural property losses may still exceed structural damage because they are so widespread.
- Nonstructural elements receive less detailed architectural and engineering attention and less building-inspection effort to ensure conformance with code requirements than do structural elements.
- The complete “collapse” of a nonstructural element is not always a major threat to life, property, or building function. The specific performance objective, or acceptability criterion, for a nonstructural element in a particular kind of building must be considered (Figure 32).

**Figure 32.** A light fixture partially fell when an anchor for one of its two safety wires pulled out at the Sylmar County (Olive View) Hospital.

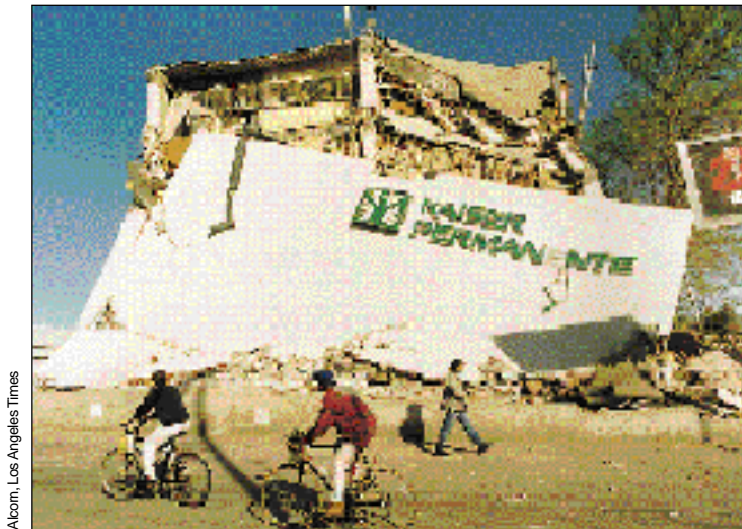
**Figure 33.** Both ends of this 1960s medical office building collapsed and the second floor “pan-caked.” Fortunately it was not occupied.

A number of building types are vulnerable to earthquakes, and in the Northridge earthquake they again demonstrated their potential to collapse and pose significant threats to life and loss of building functions. For example, the concrete columns and beams in buildings erected before the mid-1970s often lack reinforcing steel to keep them from collapsing or being damaged beyond repair in earthquakes. These buildings, like the ones shown in Figure 33, can pose the greatest threat to life in earthquakes because, though

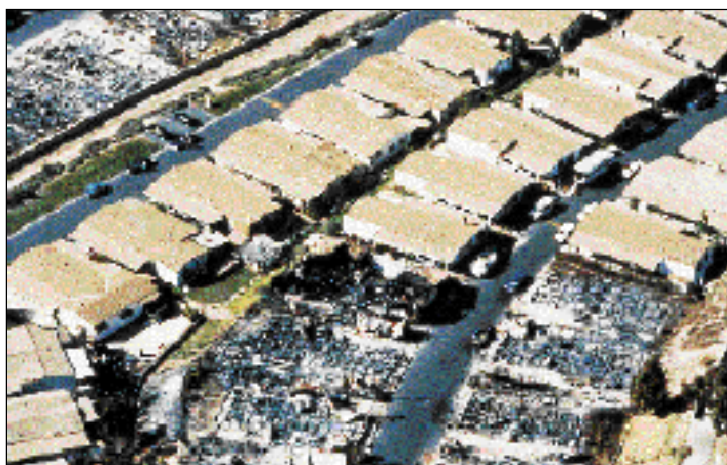
Earthquake-activated shut-off valves would probably have prevented some of the fires. However, according to HCD, some of the mobile homes that burned had shifted several feet and severed their gas lines, so individual earthquake-activated gas shut-off valves at the homes would not have prevented these fires. Fires also were started when water heaters toppled and severed their gas lines. Redesigning the gas connections for individual mobile homes to reduce the chance of breakage and installing master shut-off valves that cut off the gas flow at park entrances will reduce the risk of fire. Figure 47 depicts fire damage to mobile homes.

**Figure 47. One hundred seventy-two mobile homes burned in this earthquake. Fires most often started because of severed gas lines.**

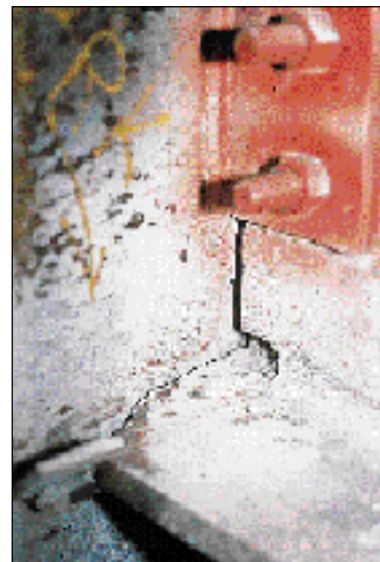
The Northridge earthquake caused unprecedented damage in a significant number of these modern buildings, primarily fractures near the beam-to-column welds and in the columns around the beam-to-column connections (see Figure 56). In most cases these failed connections were not readily apparent, as they are typically hidden by fireproofing, ceilings, and walls, but damaged steel buildings have been located both within and outside the areas of strongest shaking.

**Figure 56. Steel-frame connections were unexpectedly cracked.**

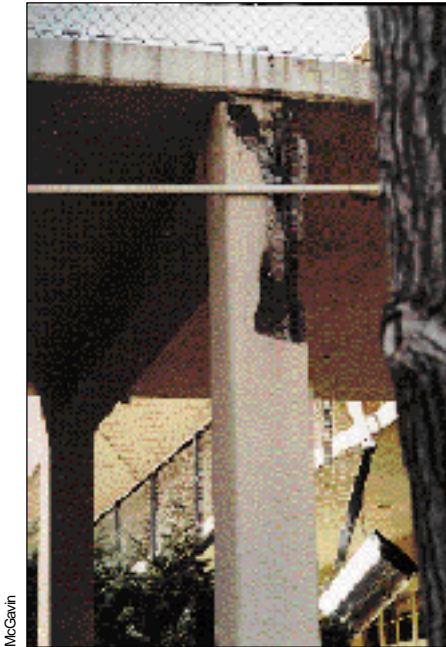
It is difficult to summarize the most typical kinds of failures or to make generalizations. There were cracks in walls, spalling of concrete columns at beam-column joints, and cracks in floors, particularly on-grade slabs. This typical structural damage was to be expected from force levels caused by intense shaking. The major portion of the damage was in structures constructed to pre-1976 building regulations, although statistics on performance are not conclusive since the heavily shaken area did not have major school construction in more recent times. An example of typical structural damage is shown in Figure 61.

**Figure 61. Damage to a concrete column on a two-story elevated walkway at Patrick Henry Junior High School. Note the failure of the guardrail in the background.**

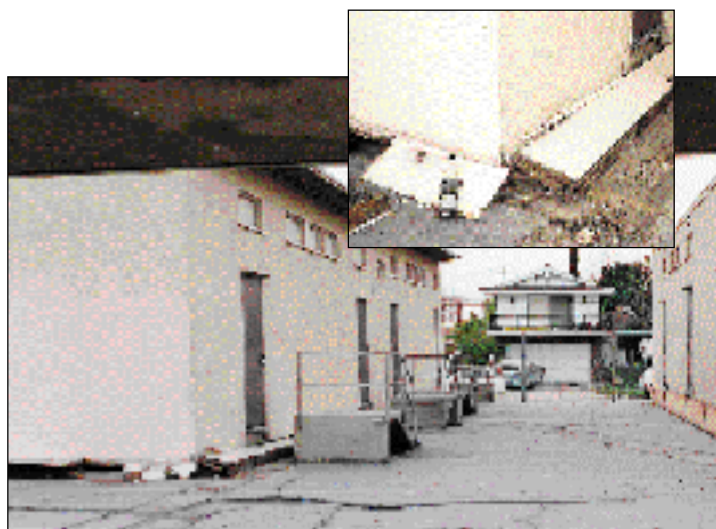
Several portable or relocatable classroom buildings were seriously damaged in the earthquake. Many units had foundation failures where the cripple walls were racked up to eight inches out of plumb. Some fell to the ground. These failures occurred in structures constructed prior to 1976 with wood foundations. Some were poorly maintained and showed evidence of rotting wood and a subsequent loosening of nails intended to resist seismic forces. See Figure 62.

**Figure 62. Several portable classrooms were seriously damaged after falling from weak or poorly maintained foundations. Inset, detail.**

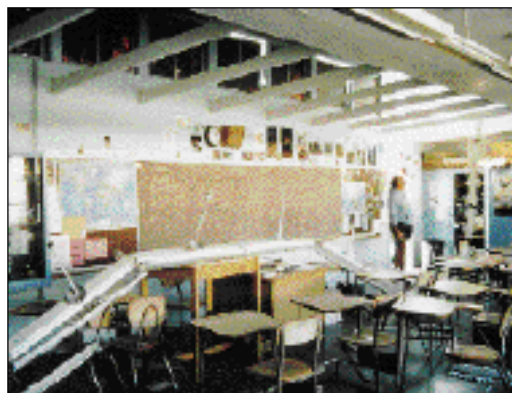
According to DSA, light fixtures fell onto desks or to the floor in approximately 100 classrooms. See Figure 64. Cracked partition walls, fallen ceiling tiles, overturned file cabinets, broken window panes, failed light fixture supports, and broken sprinkler water lines were evident in many school buildings located in the strongly shaken area. DSA found many methods for reducing nonstructural damage were quite effective.

**Figure 64.** Falling light fixtures in over 100 classrooms would have posed significant threats to students and teachers had the earthquake occurred during school hours.

- All public-school and community college districts evaluate nonstructural elements and abate unacceptable hazards. The Field Act should be amended to require DSA to adopt retroactive, mandatory retrofit standards regarding nonstructural hazards. Public-school and community college districts should be required to abate nonstructural and building contents hazards when undertaking major alterations, additions, renovations, or repairs. In any event, retrofits should be completed no later than 2010.
- A percentage of future school bond proceeds be used to abate life-threatening nonstructural and building contents deficiencies in public schools by 2010.

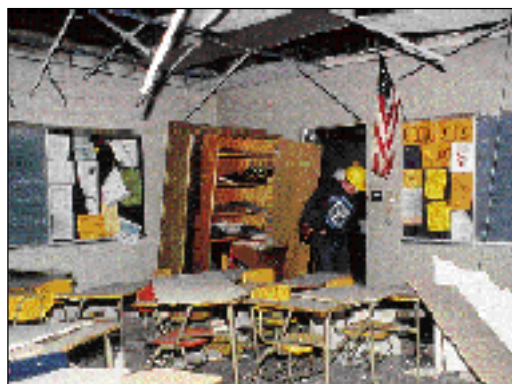
tive in this earthquake. The older buildings had proportionally more damage, which suggests that many of these hazards can be reduced by retrofitting existing schools with current methods (see Figure 65).

**Figure 65.** Though less life-threatening than light fixtures, ceiling tiles were a major property loss that could have been reduced with modern bracing techniques.

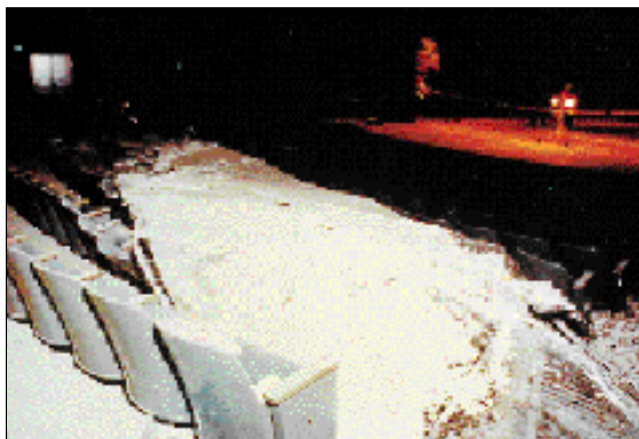
- Exterior plaster soffits* (exterior ceilings and overhangs) and wall finishes failed in several buildings that are considered modern (see Figure 26 and Figure 67). Under present inspection practices it is difficult to verify that these elements were constructed with adequate anchorage because several installation steps are involved, and detailed inspections of each phase are not a typical building inspection practice. Once in place, verification is even more difficult. Whereas the earthquake bracing of a lightweight suspended ceiling can usually be inspected by removing the

- *Royce Hall*, built in the 1920s, sustained structural damage. It is a popular symbol of the University and houses the main campus auditorium (see Figure 67) and classrooms for a diverse group of academic programs offered by the College of Letters, Arts, and Sciences. This structure had been identified as one of the seven "very poor," or most vulnerable, structures on campus. The structural damage was primarily in the two towers at the entrance. Because these towers stand over the main entrance, it was necessary to close the building. The seismic deficiency of these towers had been noted in a UCLA seismic committee review and a design team was in the process of designing seismic retrofit measures at the time of the earthquake.

**Figure 67.** Large sections of a heavy plaster ceiling came down in Royce Hall. At another time of day, injuries and possibly deaths would have resulted.
